FIELD INSPECTION

Project Name: Mountain Valley Pipeline Date: Monday, November 26, 2018

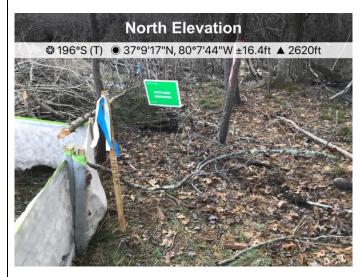
Fig. 4 Wetland perimeter at St#12867+64
